Santa Marija Church,

Birkirkara, Malta.

Structural and geotechnical considerations in view of observed cracks

Report of work carried out and proposed action

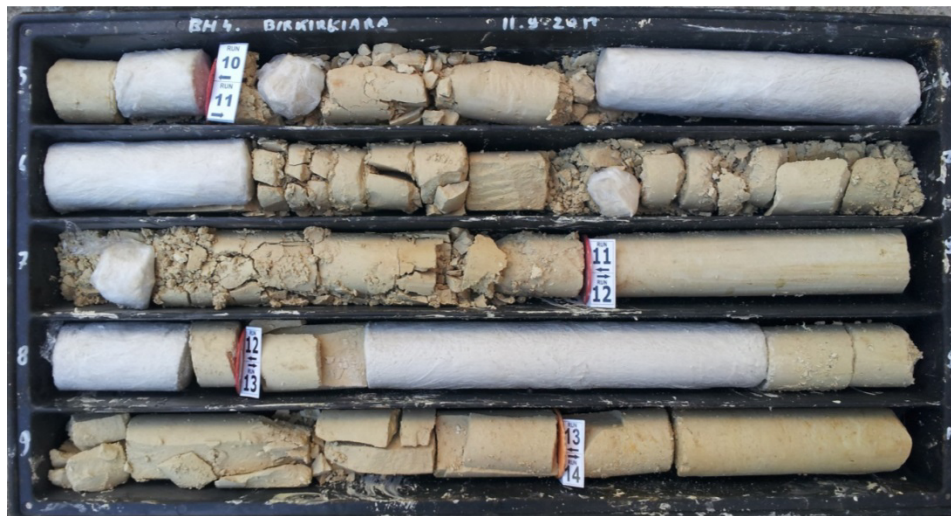
the first three boreholes, but also allowed higher quality samples to be extracted and preserved for analysis in the laboratory. Parts of the retrieved borehole core were sealed to enable the moisture content to be preserved over a long time, for further study.

Figure 1 - Borehole core from investigation in September 2012

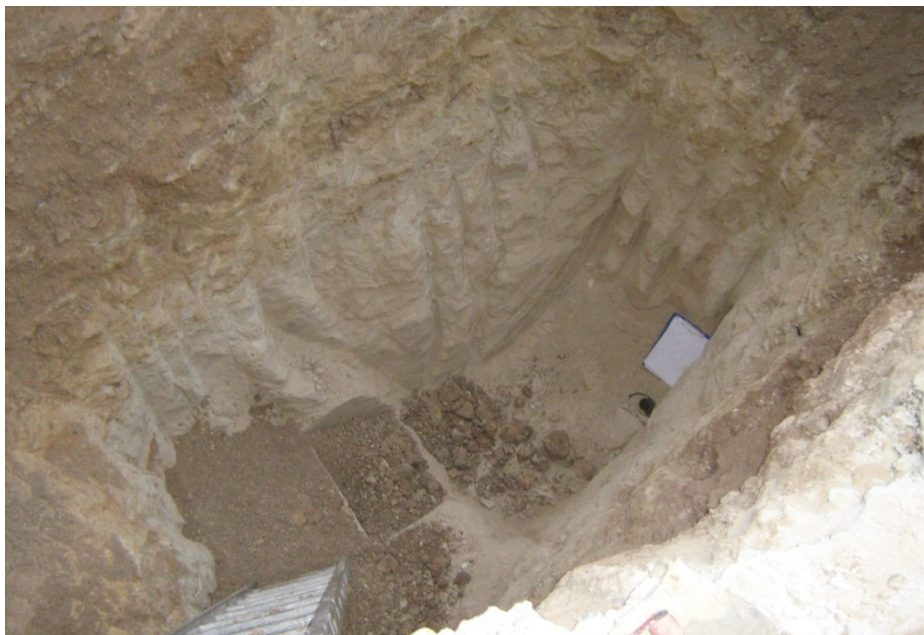
In October 2012, a trial pit was also excavated next to the façade of the church, down to a depth of 3.5m, thus allowing the upper hard crust and the underlying softer rock to be inspected at close range. A small section of the foundations of the church façade were also exposed in this trial pit. Several block samples of the weaker rock material were taken, sealed in plastic and wax and stored in a damp environment for subsequent analysis in the laboratory.

Figure 2 - Trial pit excavated below the West front, October 2012

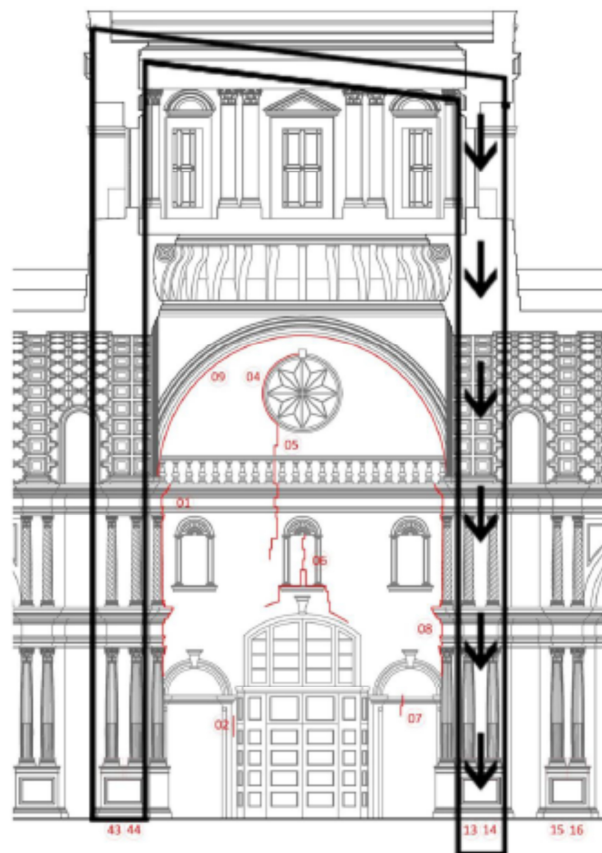
Figure 3 - One of several drawings showing crack patterns and perceived distortional mechanisms within the church structure

The findings of this study have clearly shown that the cracks visible within the church are not the result of a one-off event, but represent an ongoing process. Efforts have been made to monitor the structure more closely ever since this was realised, and recent surveys have confirmed the development of new cracks and the widening of existing ones.

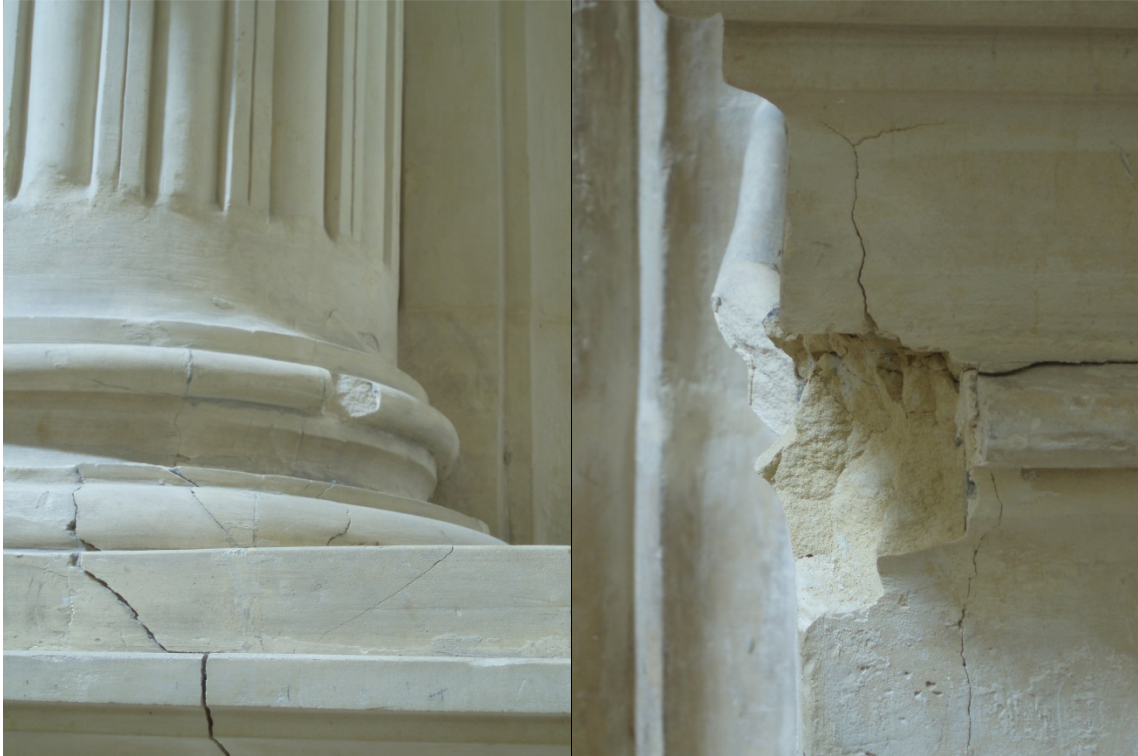
Figure 4 - Some of the observed cracks within the church

Possible interventions could include underpinning of the church foundations (by transferring loads to stronger strata at depth using piles), treatment of the ground, reinforcement of the structure, ties at foundation level and micropiling in less accessible areas below the dome supporting structures. In any case, such works would need to be carried out by specialist contractors who are experienced in carrying out such interventions on historic structures. Any form of intervention would also need to be studied from the point of view of conservation specialists and restorers. Above all, the impact of such works on the historical and architectural value of this Grade 1 listed building needs to be considered very carefully.

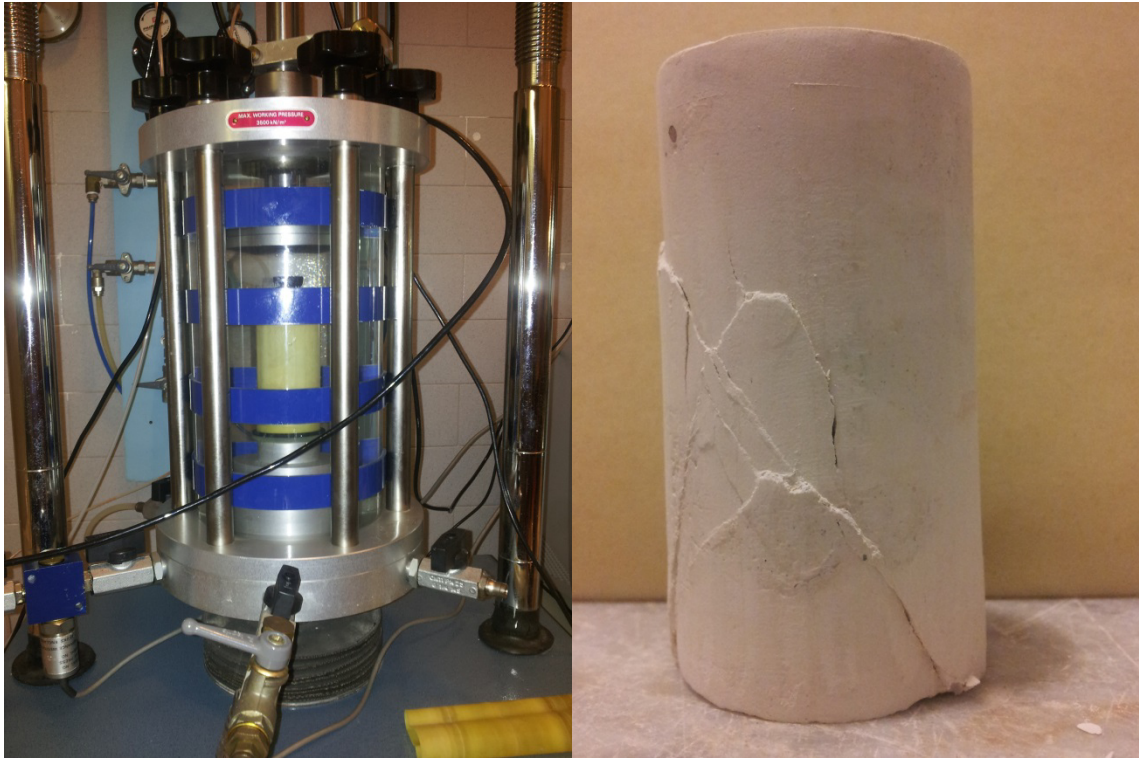
The second study, being carried out by the undersigned, consisted in the classification and strength testing of the natural ground material found beneath the church. This is being carried out on the retrieved borehole core and on the block samples extracted from the trial pit. Detailed studies of the microstructure of this material have been carried out, using the scanning electron microscope at the University of Malta, and also by carrying out a series of laboratory tests both in Malta and in Italy. This study has now reached a phase where the strength, deformational and permeability characteristics of the material are being investigated. Initial results have already shone light on possible deformational mechanisms occurring within this material when it is loaded, and some hypotheses regarding the effect of this on the observed cracks have already been made.

Figure 5 – Triaxial cell and sheared specimen of rock from beneath the church (Bari Politecnico)
